**Subject: Asbestos Containing Materials Survey  
Alexander Graham Bell Elementary School  
3730 North Oakley Avenue  
Chicago, Illinois 60618**

## **Asbestos Containing Materials Survey**

**Project Site:**  
**Alexander Graham Bell Elementary School**  
**3730 North Oakley Avenue**  
**Chicago, Illinois 60618**

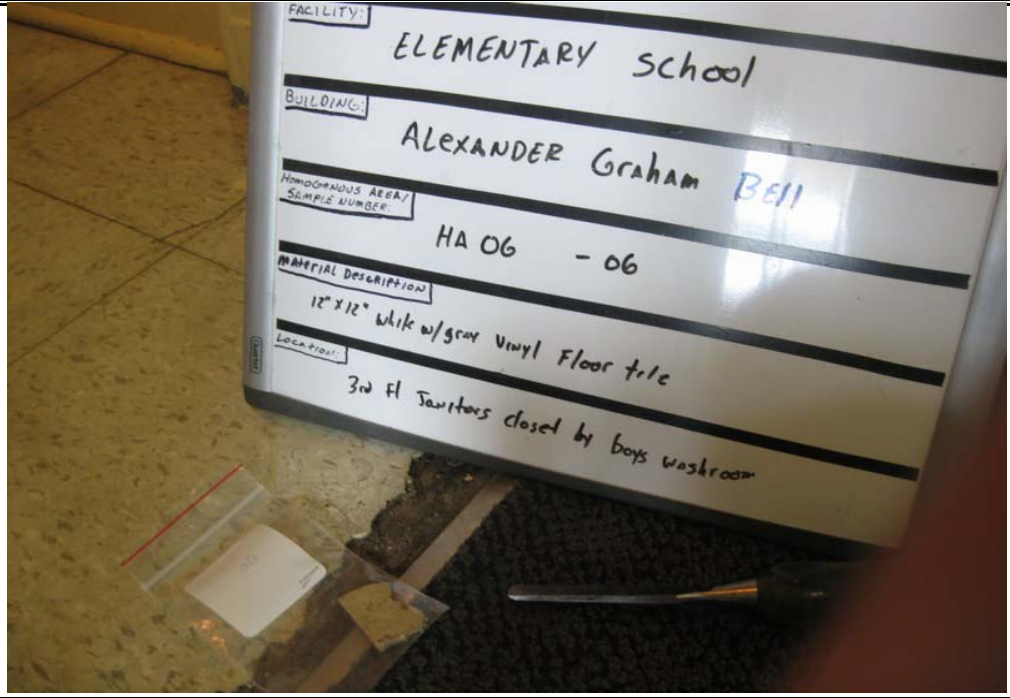
Photo #1

Description:  
12" x 12" Floor tile from  
Janitor's Closet (third  
floor)

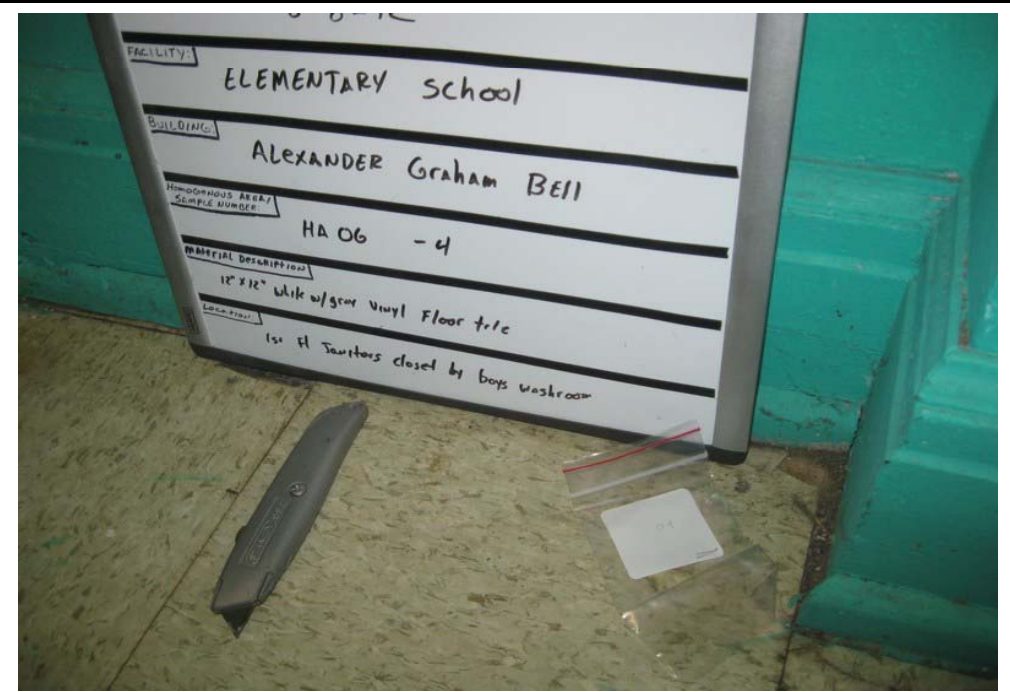
Photo #2

Description:  
12" x 12" Floor tile from  
Janitor's Closet (first  
floor)

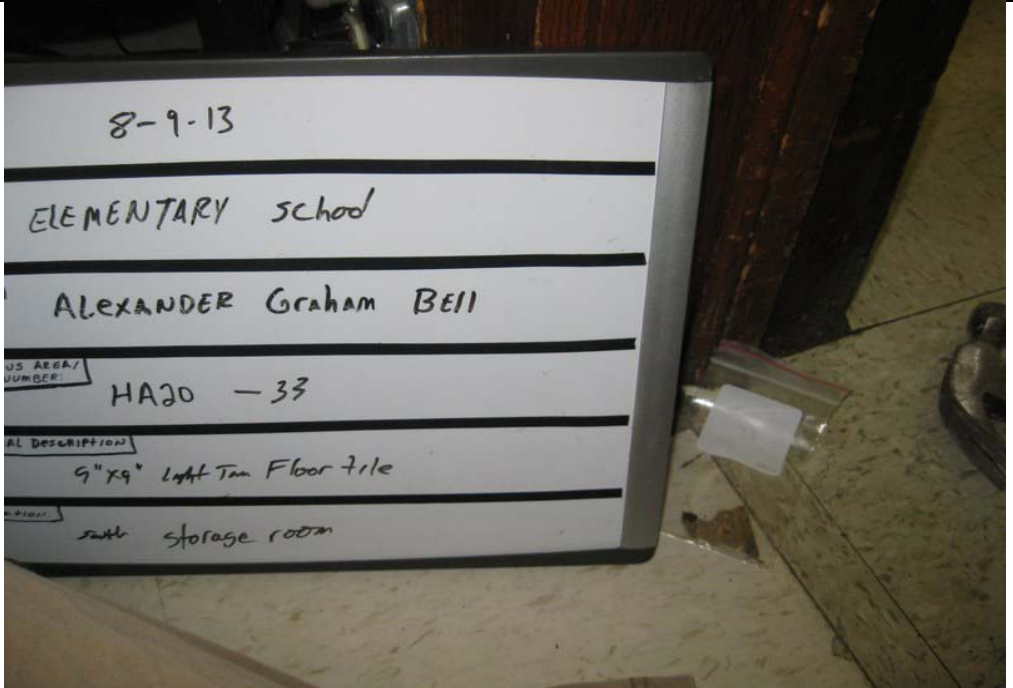
<p>Description:          9" x 9" tan floor tile          from Lunchroom South          Storage Room</p> <p>Photo #5</p>

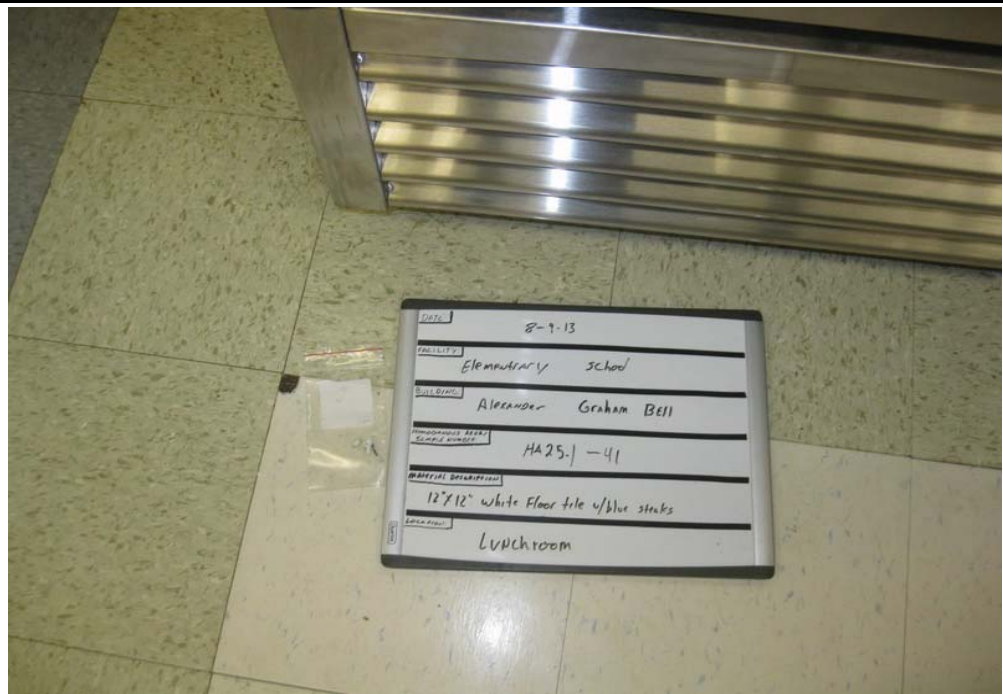
Photo #8

Description:  
 12" x 12" white floor  
 tile with blue specks  
 from the Lunchroom  
 area

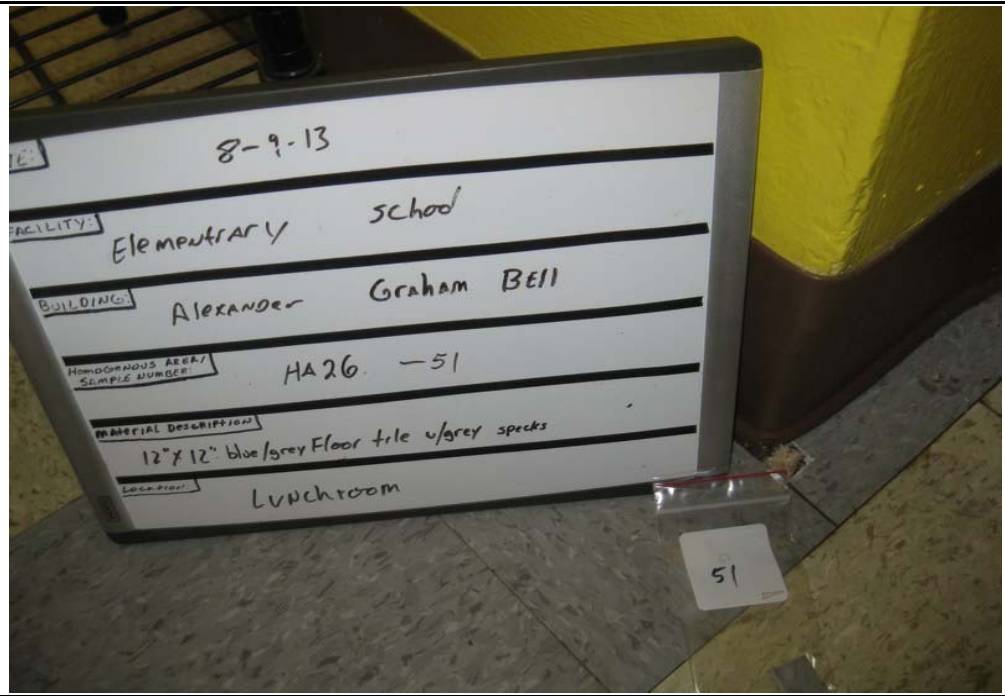
Photo #9

Description:  
12" x 12" blue/gray  
floor tile with gray  
specks from the  
Lunchroom area

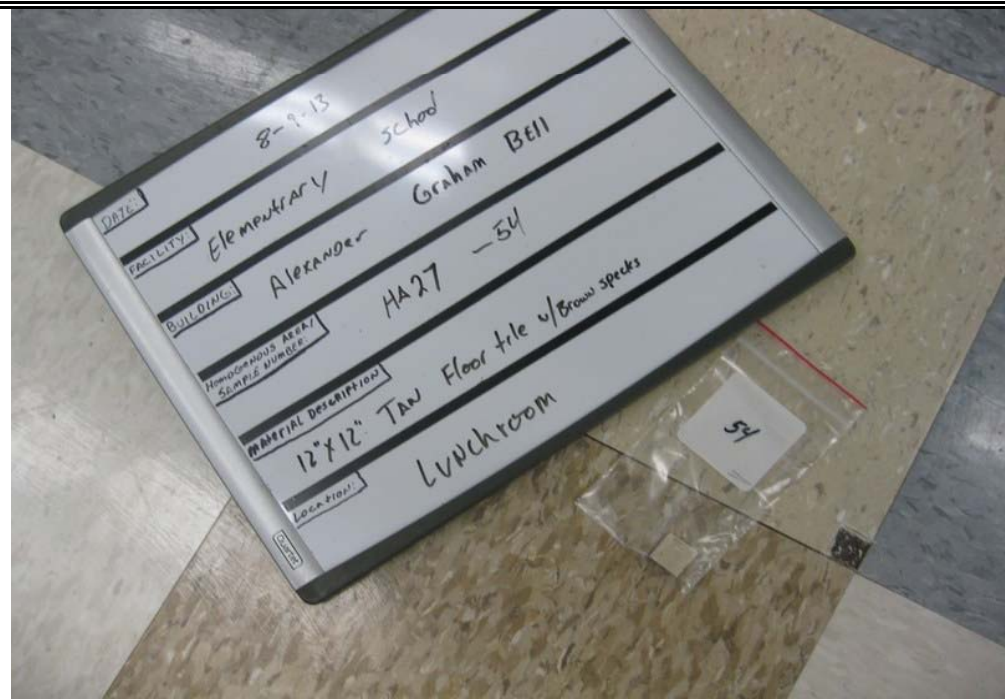
Photo #10

Description:  
12" x 12" tan floor tile  
with brown specks from  
the Lunchroom area

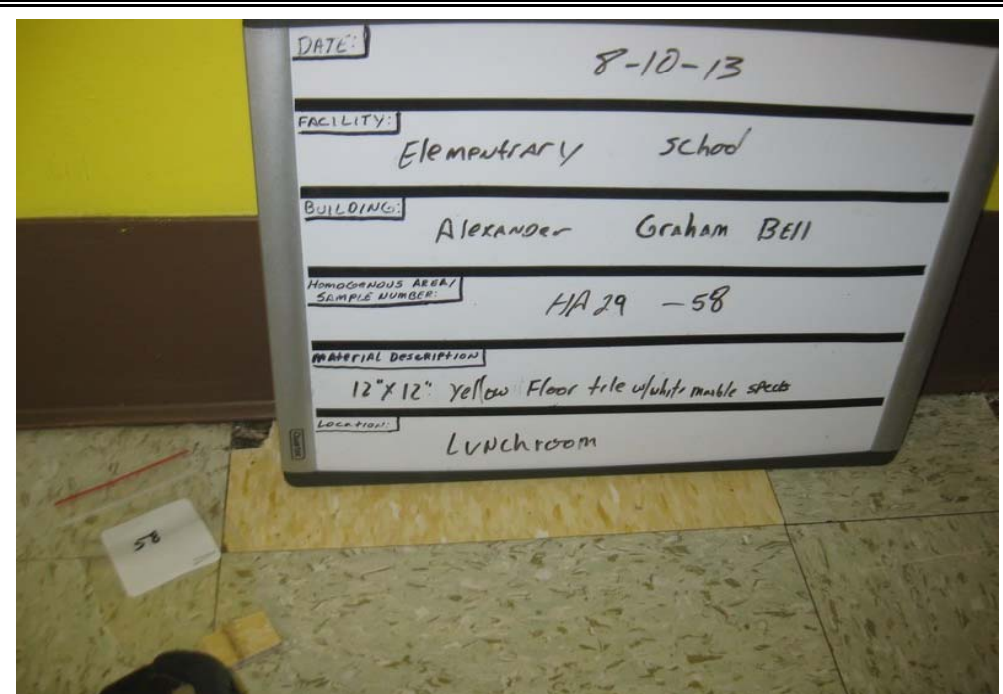
<p>Description:          12" x 12" yellow floor tile with white marble specks from the Lunchroom area</p>	
Photo #12

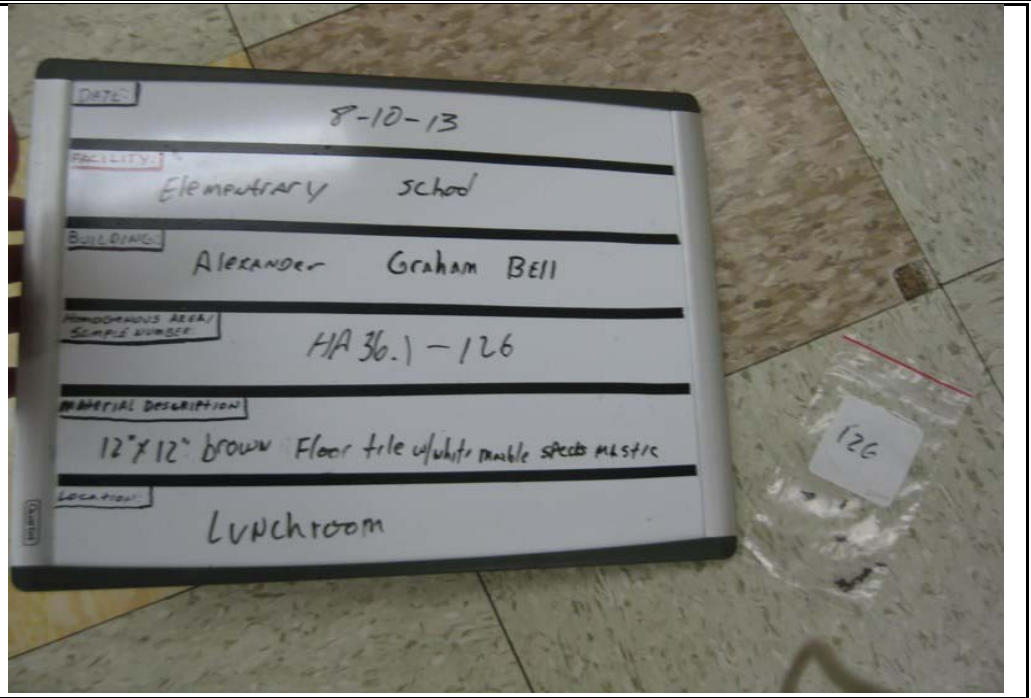
Photo #13

Description:  
12" x 12" brown floor  
tile with white marble  
specks from the  
Lunchroom area

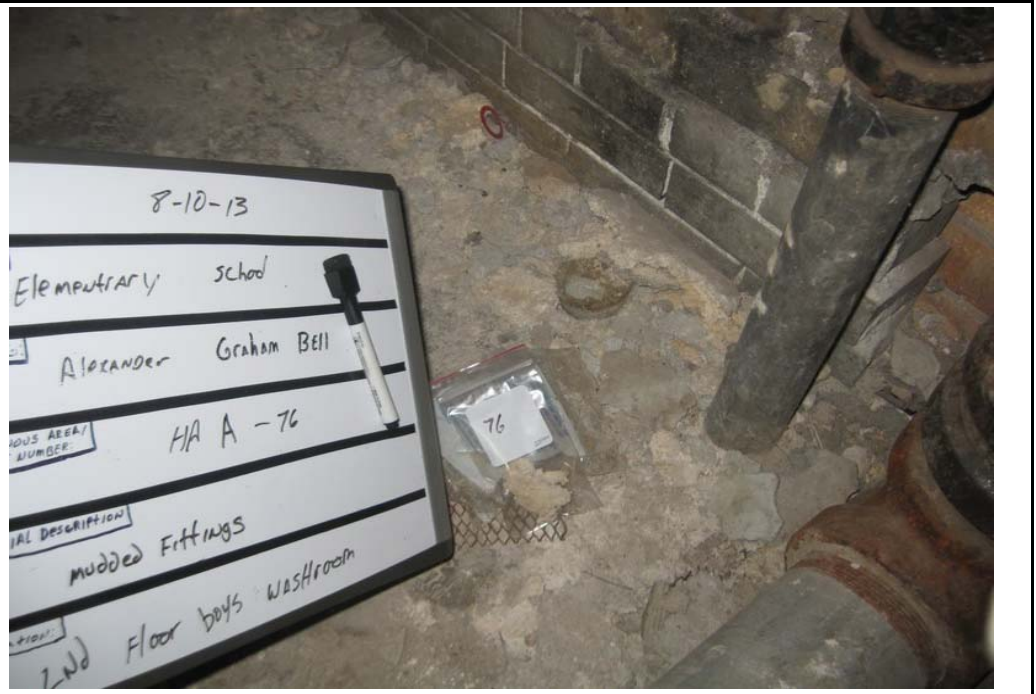
Photo #14

Description:  
Mudded fitting sampled  
from Boy's Bathroom on  
second floor  
(representative of all  
bathrooms)

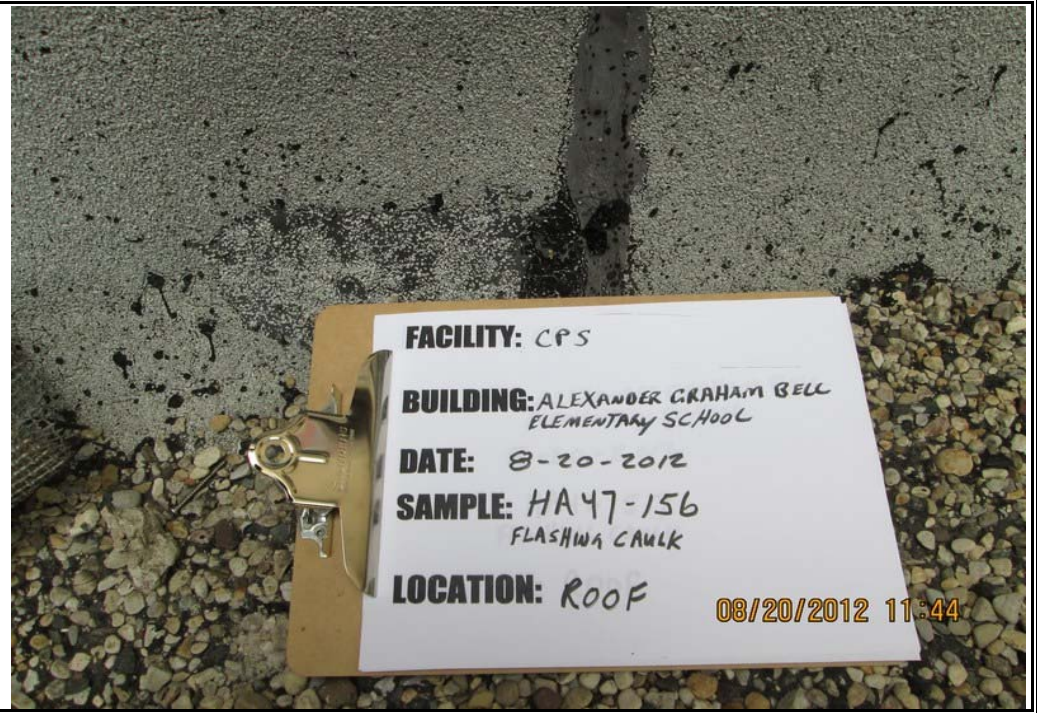
Photo #17

Description:  
Roof flashing caulk  
sampled from third floor  
roof

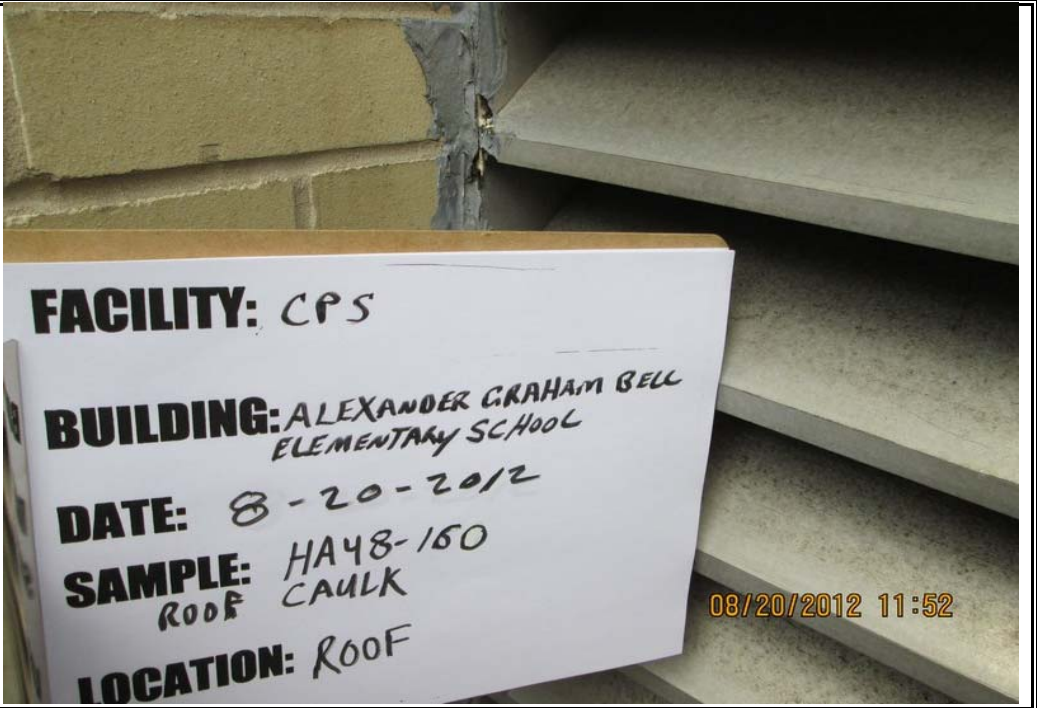
Photo #18

Description:  
Roof caulk sampled  
from third floor roof

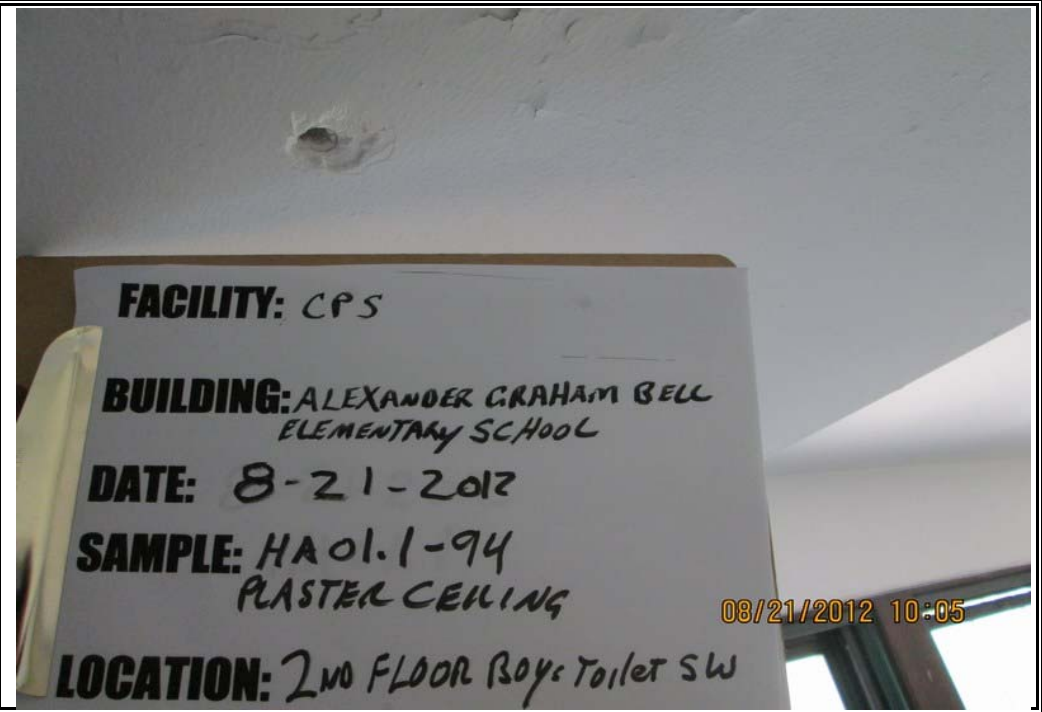
<p>Description: Sample location for plaster ceiling</p> <p>Photo #23</p>

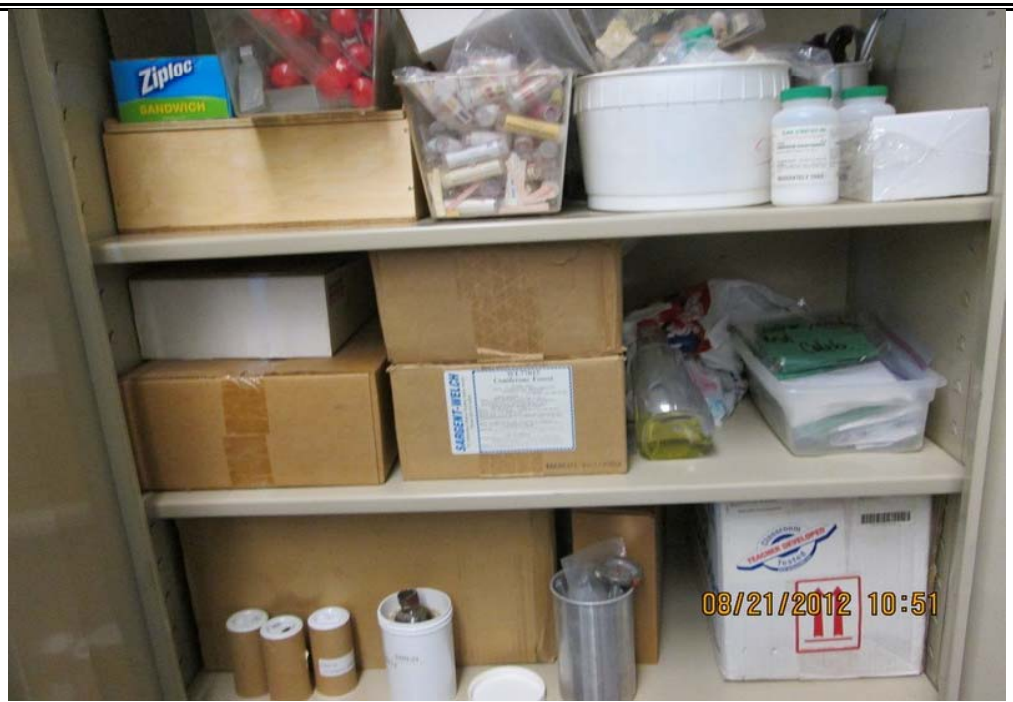
Photo #4

Description:  
Metal cabinet with  
additional hazardous  
material from Room  
314B

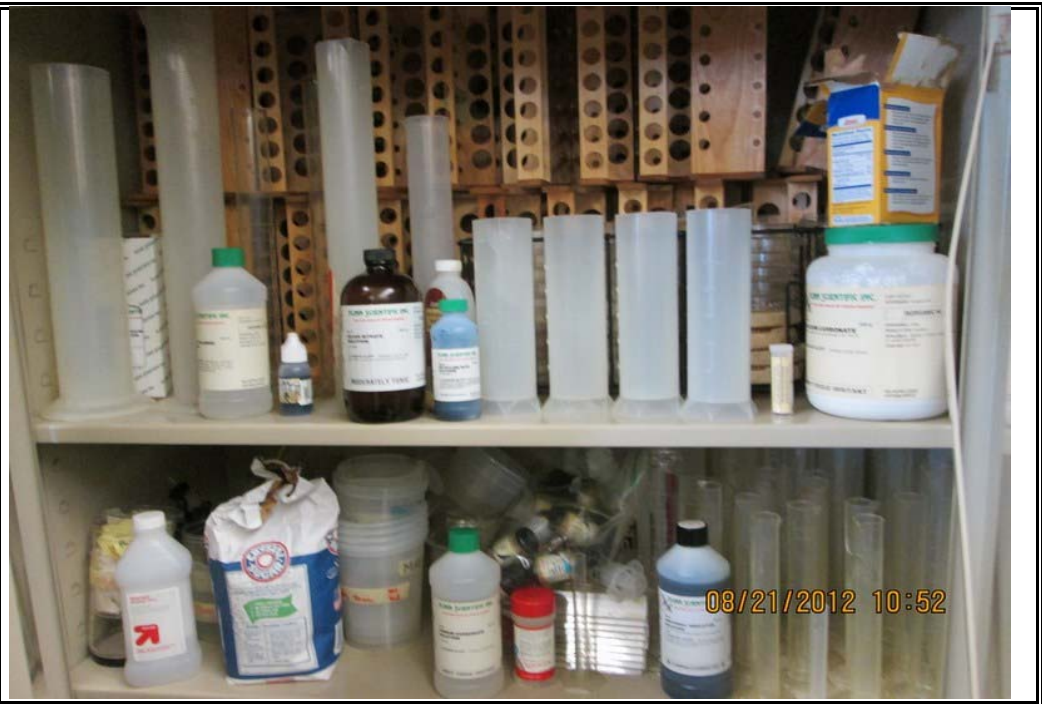
Photo #5

Description:  
More hazardous  
laboratory material from  
Room 314B

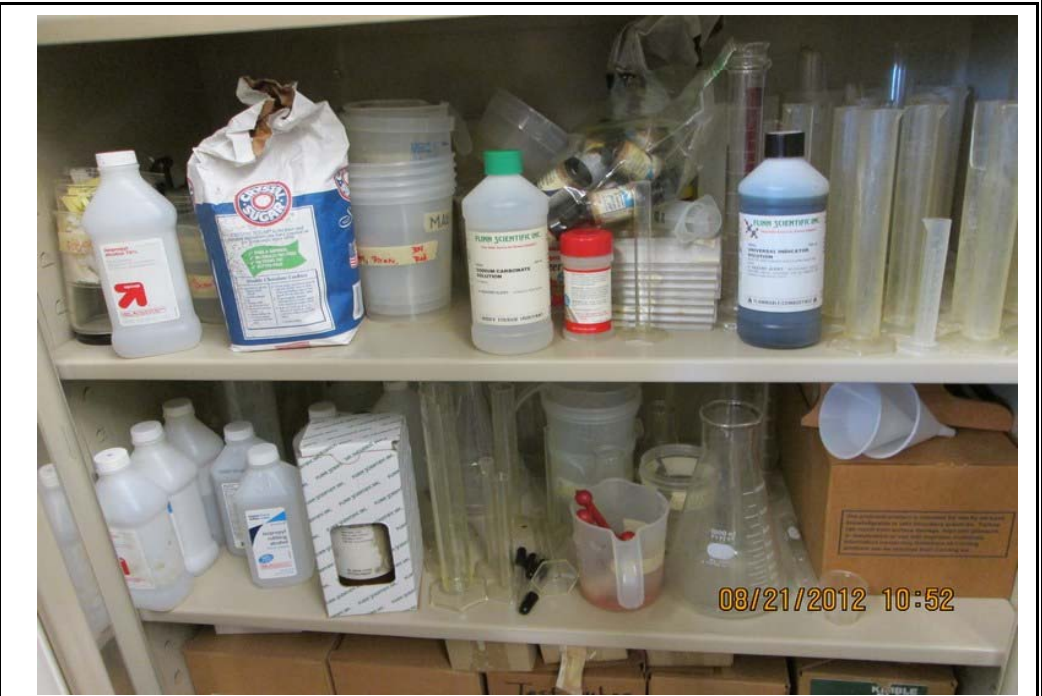
Photo #6

Description:  
More hazardous  
laboratory material from  
Room 314B

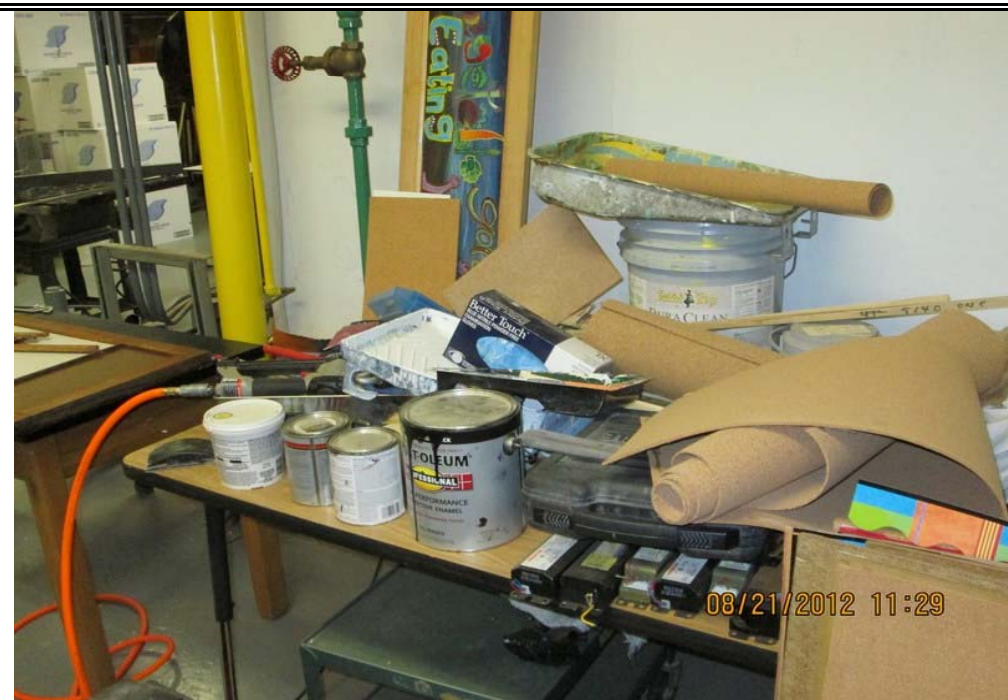
Photo #10

Description:  
Paint and paint-related  
products located in the  
Boiler Room.  
Photograph also shows  
non-PCB containig light  
ballasts

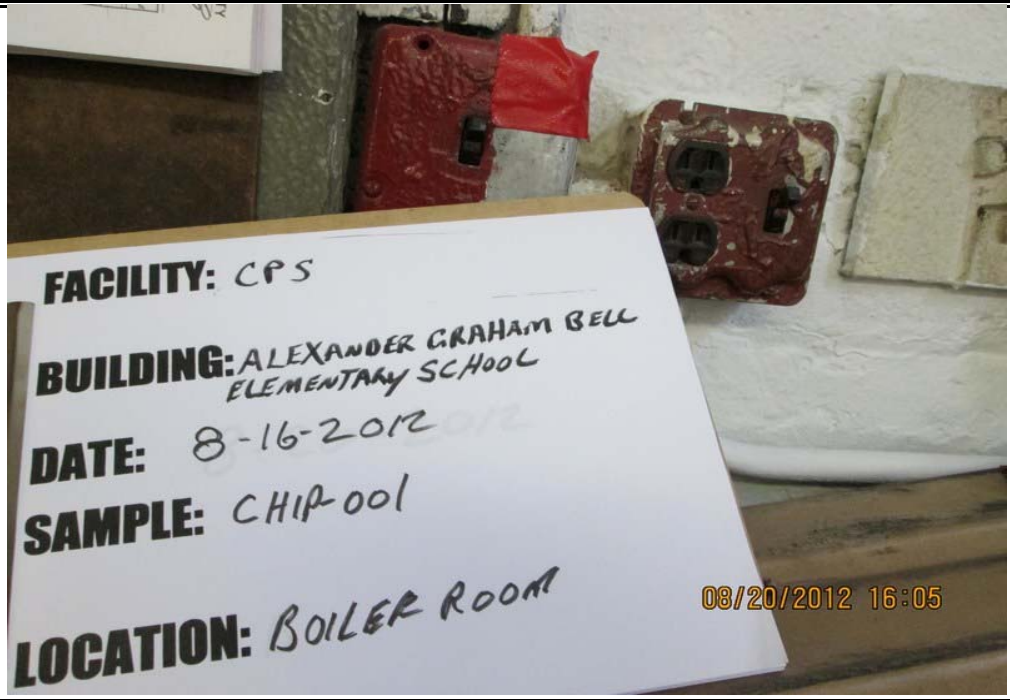
Photo #1

Description:  
Light switch in Boiler Room where paint chip sample was collected (repaired with tape following sample collection)
