AS BUILT CONDITIONS MAP HAAS PARK FIELD HOUSE CHICAGO, ILLINOIS

PREPARED FOR:
 PACIFIC CONSTRUCTION

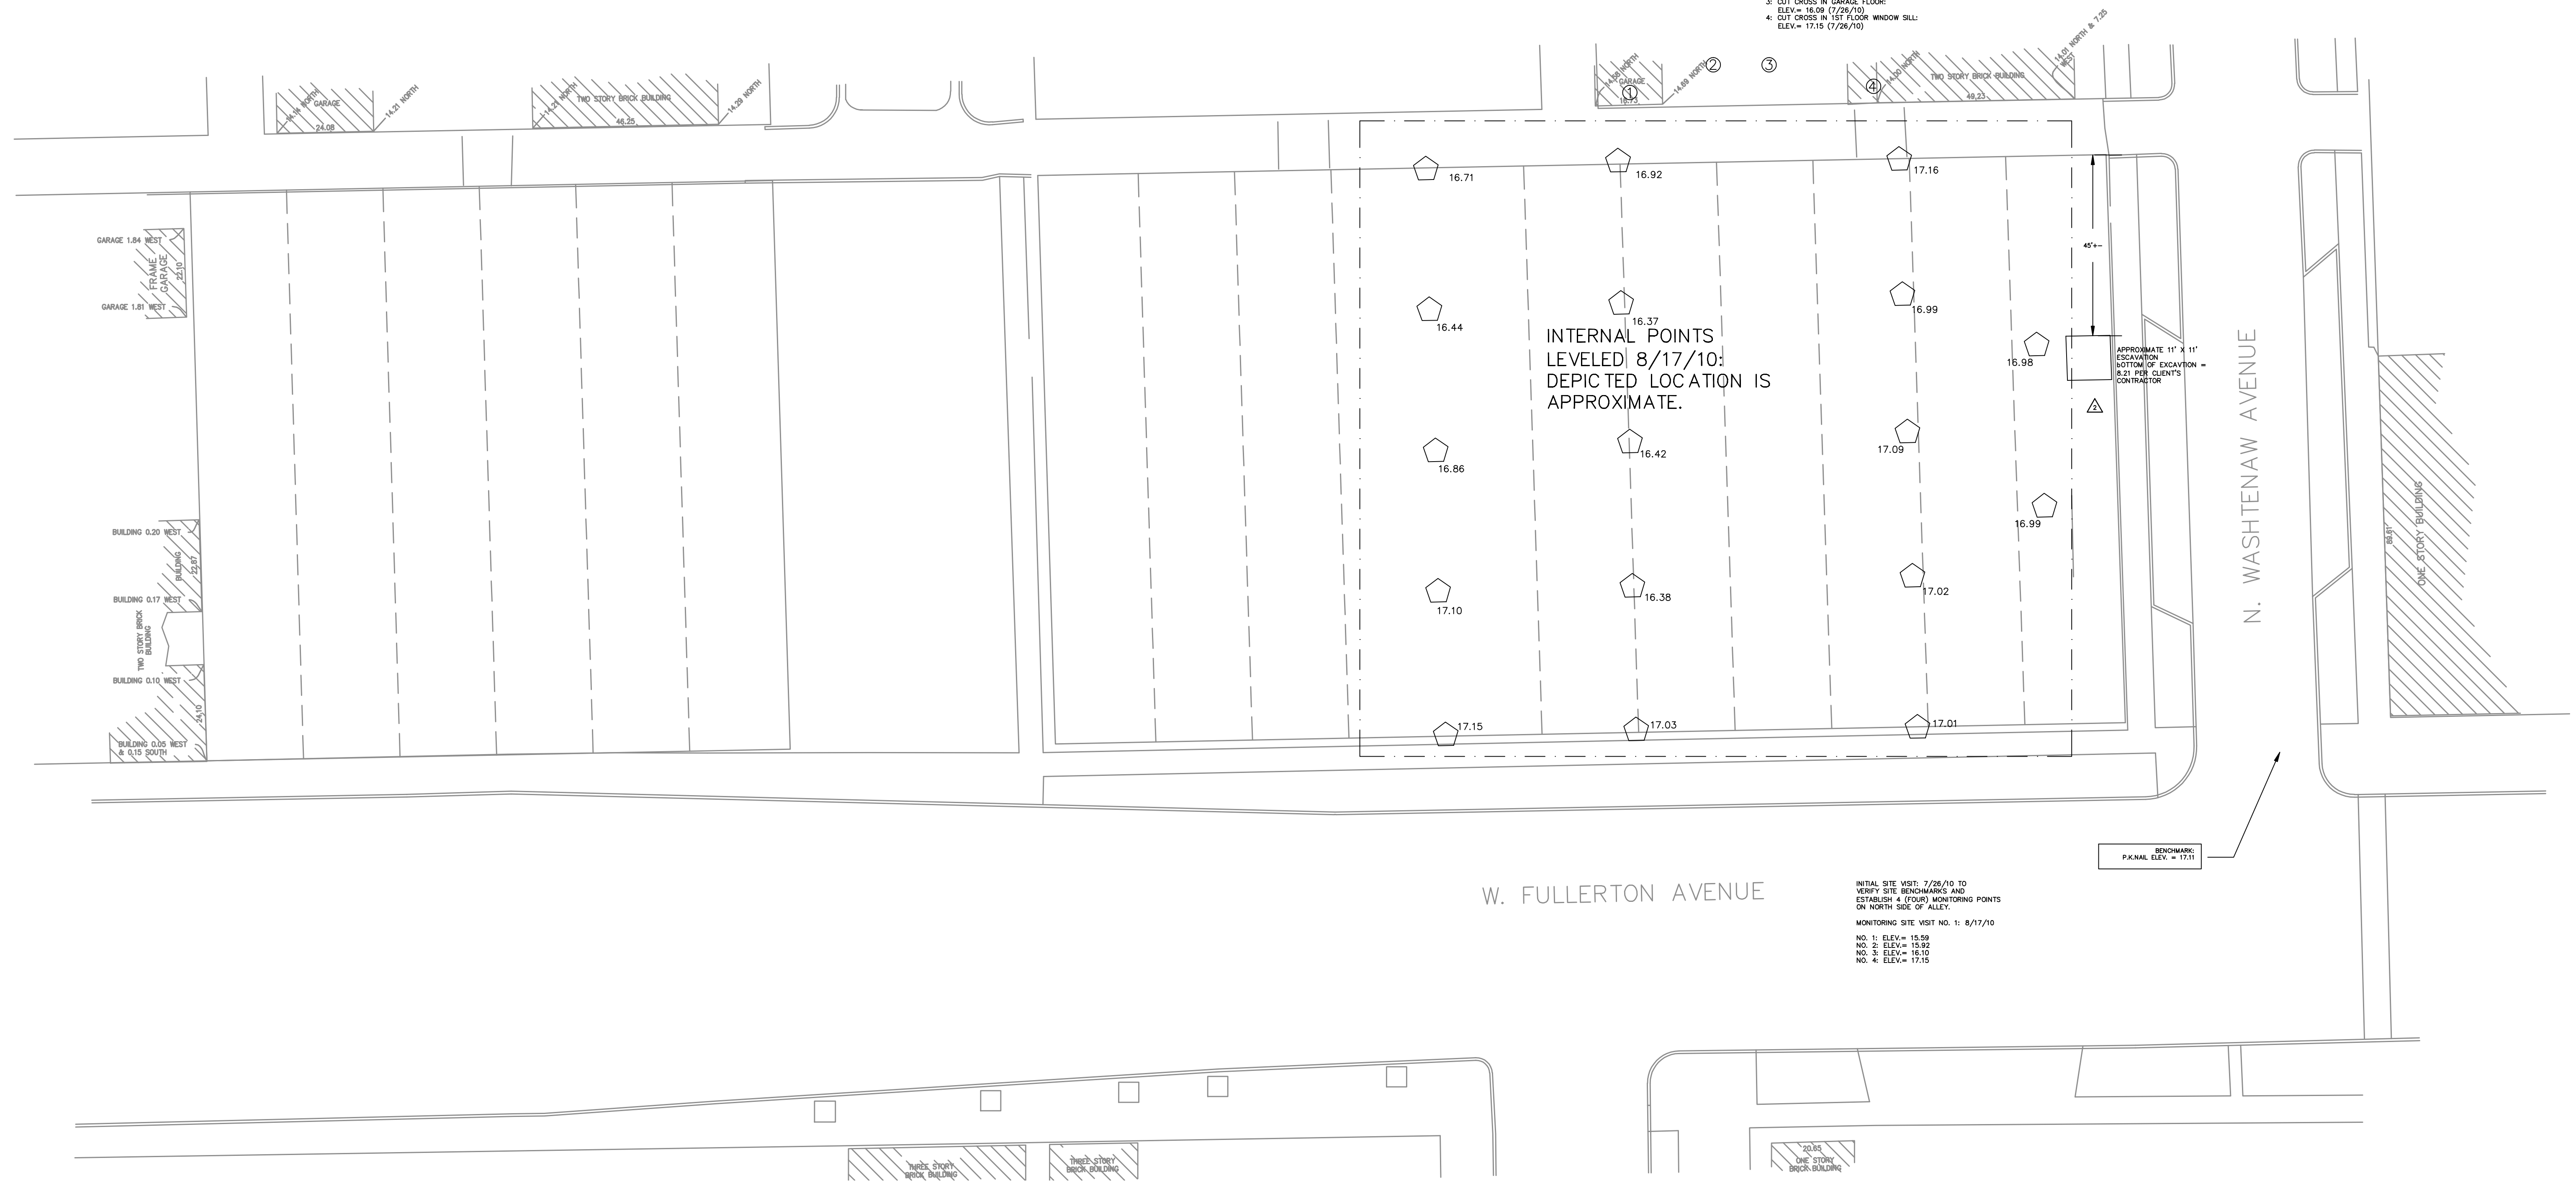
NOTE: ALL LOCATIONS DEPICTED HEREON ARE APPROXIMATE AND ARE TO BE USED FOR ELEVATION REFERENCE ONLY. NO HORIZONTAL POSITION SHOULD BE DERIVED FROM THIS MAP.

- 1: CUT CROSS IN GARAGE FLOOR:
ELEV. = 15.59 (7/28/10)
- 2: CUT CROSS IN GARAGE FLOOR:
ELEV. = 15.92 (7/28/10)
- 3: CUT CROSS IN GARAGE FLOOR:
ELEV. = 16.09 (7/28/10)
- 4: CUT CROSS IN 1ST FLOOR WINDOW SILL:
ELEV. = 17.15 (7/28/10)
