**Subject: Asbestos Containing Materials Survey  
Alexander Graham Bell Elementary School  
3730 North Oakley Avenue  
Chicago, Illinois 60618**

## **Asbestos Containing Materials Survey**

**Project Site:**  
**Alexander Graham Bell Elementary School**  
**3730 North Oakley Avenue**  
**Chicago, Illinois 60618**

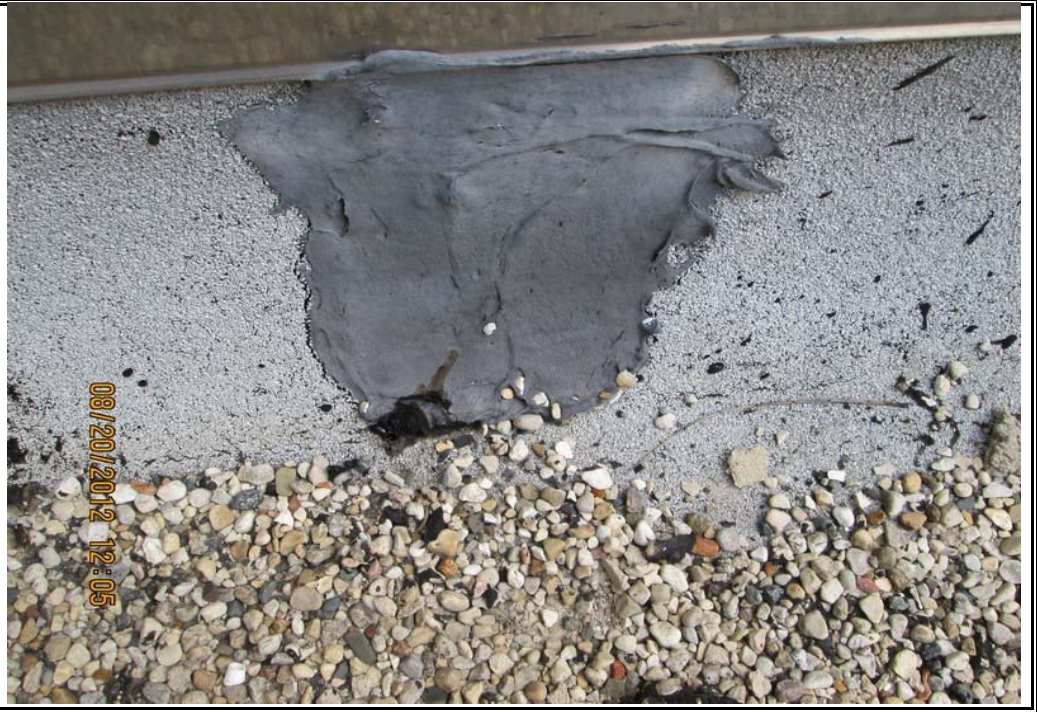
Photo #21

Description:  
Repaired roof patch  
sample location

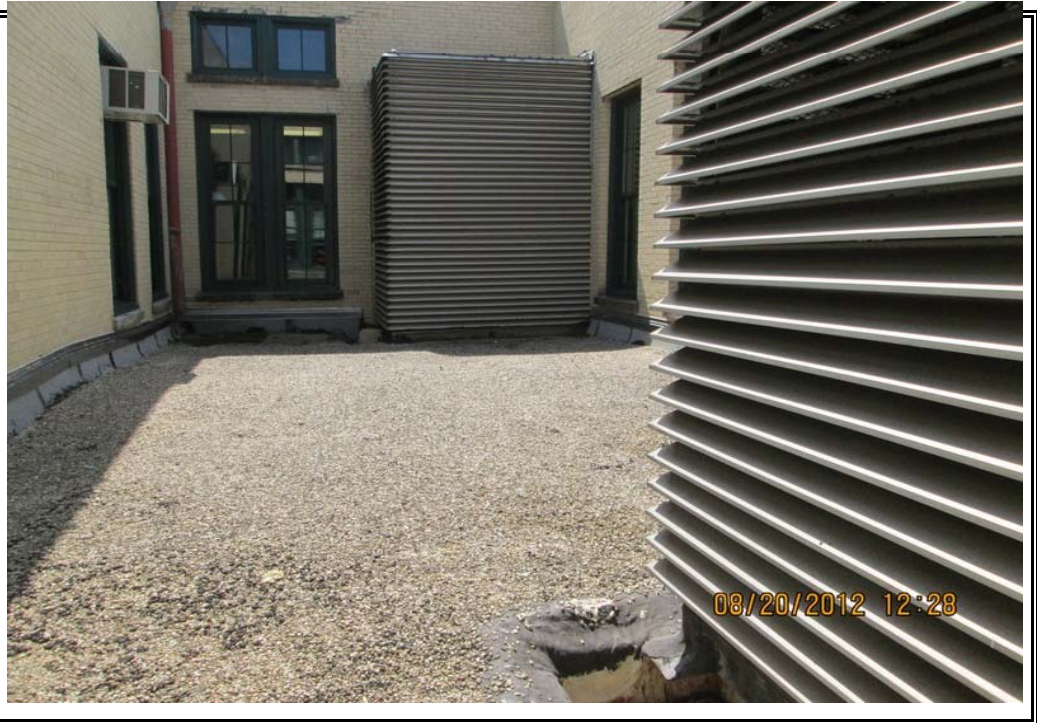
Photo #22

Description:  
Access point from third  
floor to third floor roof

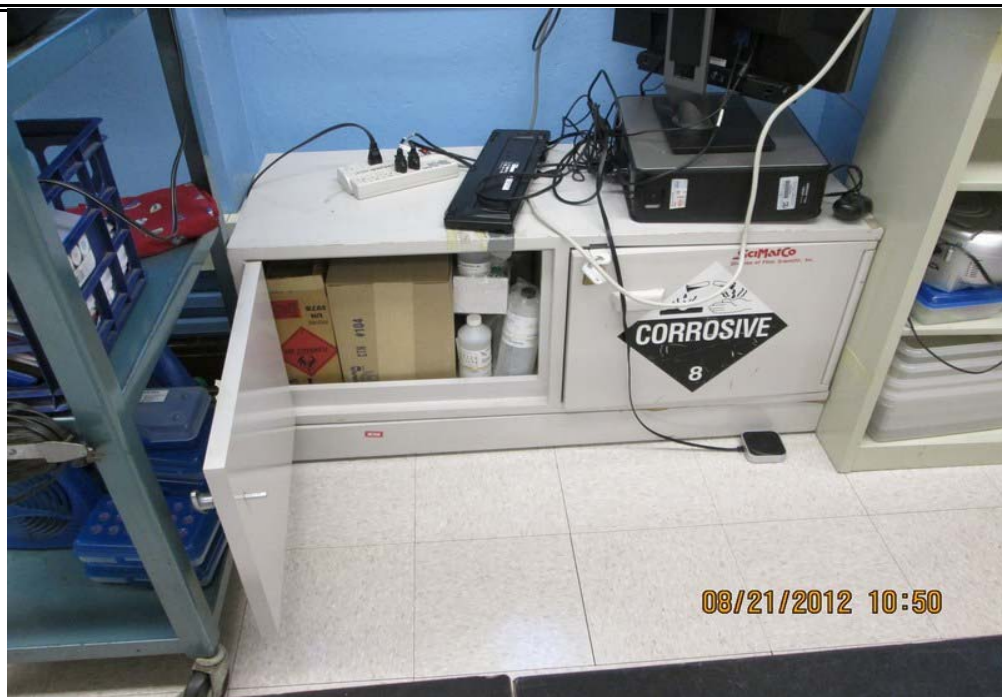
Photo #1

Metal cabinet used to store Corrosive laboratory chemicals in Room 314B

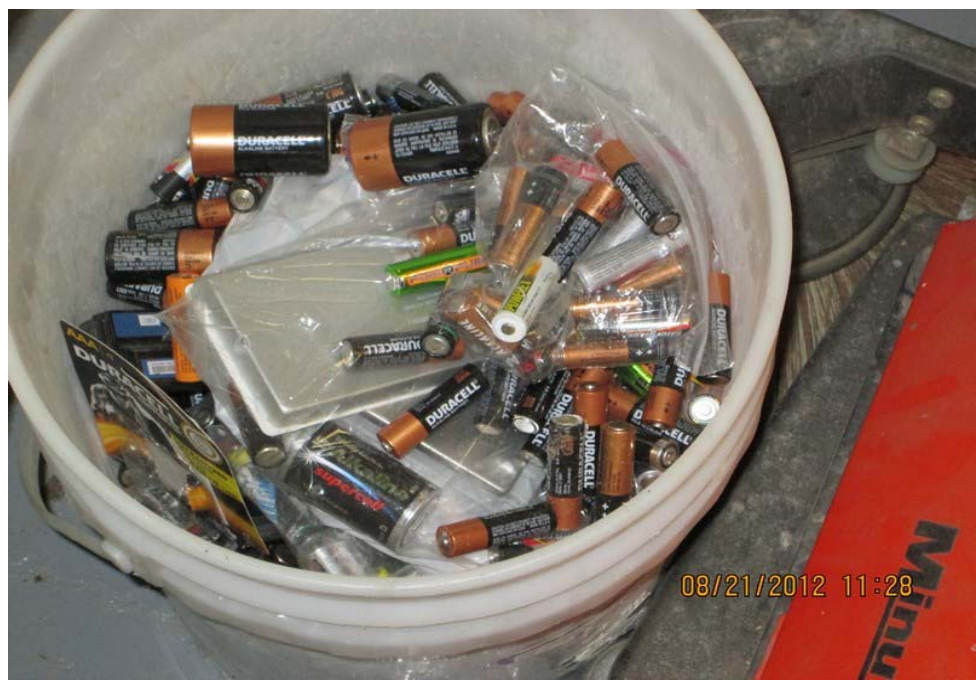
Photo #7

Description:  
5-Gallon Bucket  
containing used batteries  
located in the Boiler  
Room

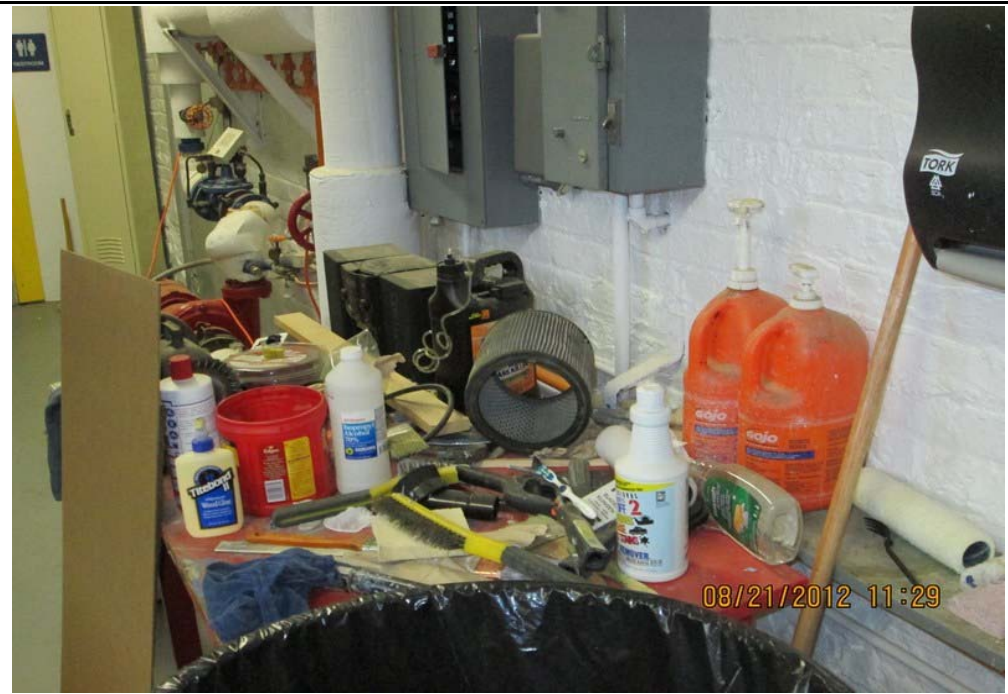
Photo #9

Description:  
Miscellaneous  
Operations and  
Maintenance (O&M)  
products located in the  
Boiler Room

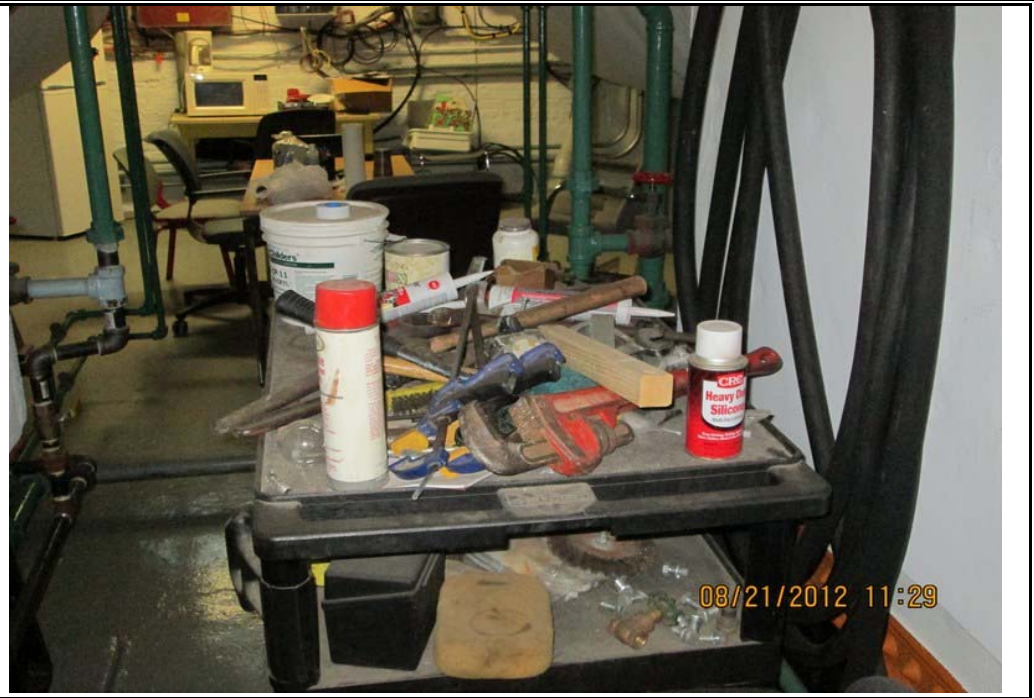
Photo #11

Description: Miscellaneous O&M products located in the Boiler Room
---

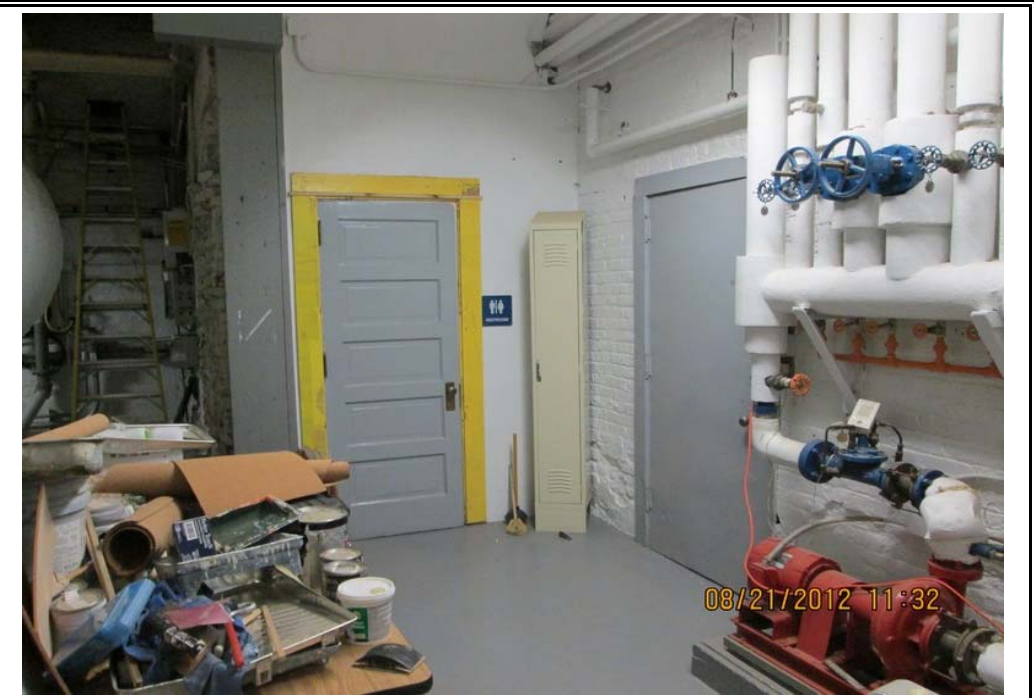
Photo #12

Description: Reverse angle shot of paint and paint-related products shown in Photo # 10
---

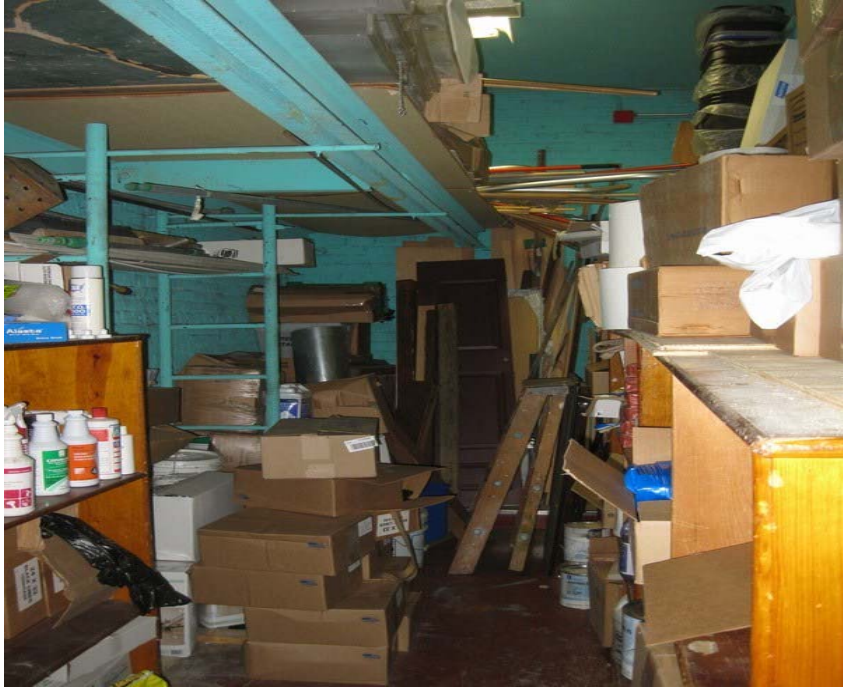
Photo #13

Description: Miscellaneous O&M products located in the Boiler Room

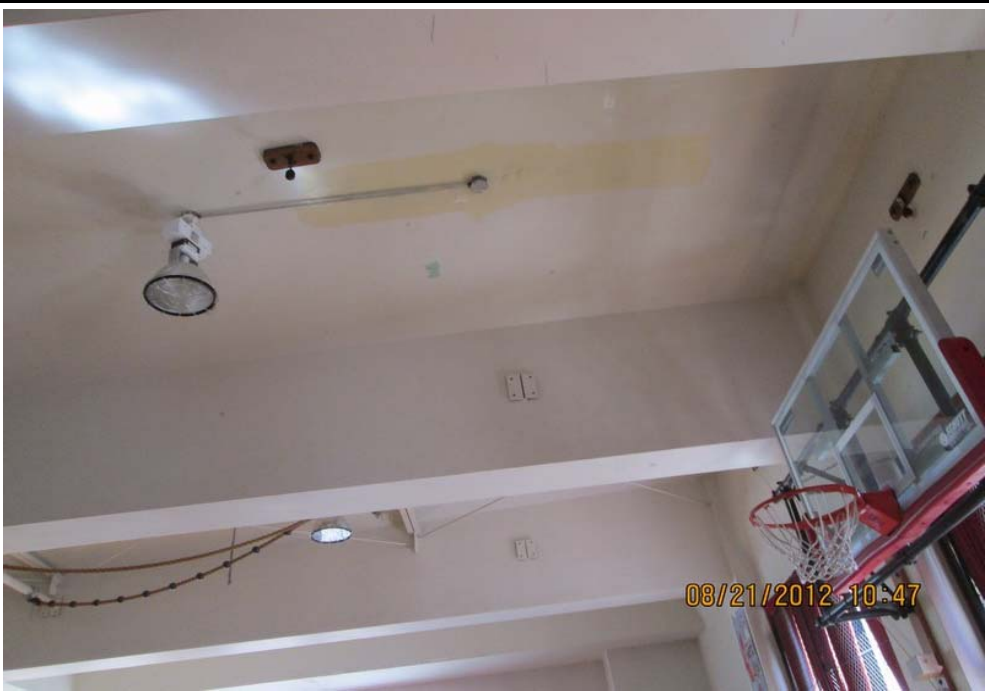
Photo #14

Description: High Intensity Multi- Vapor® lighting in the Gymnasium

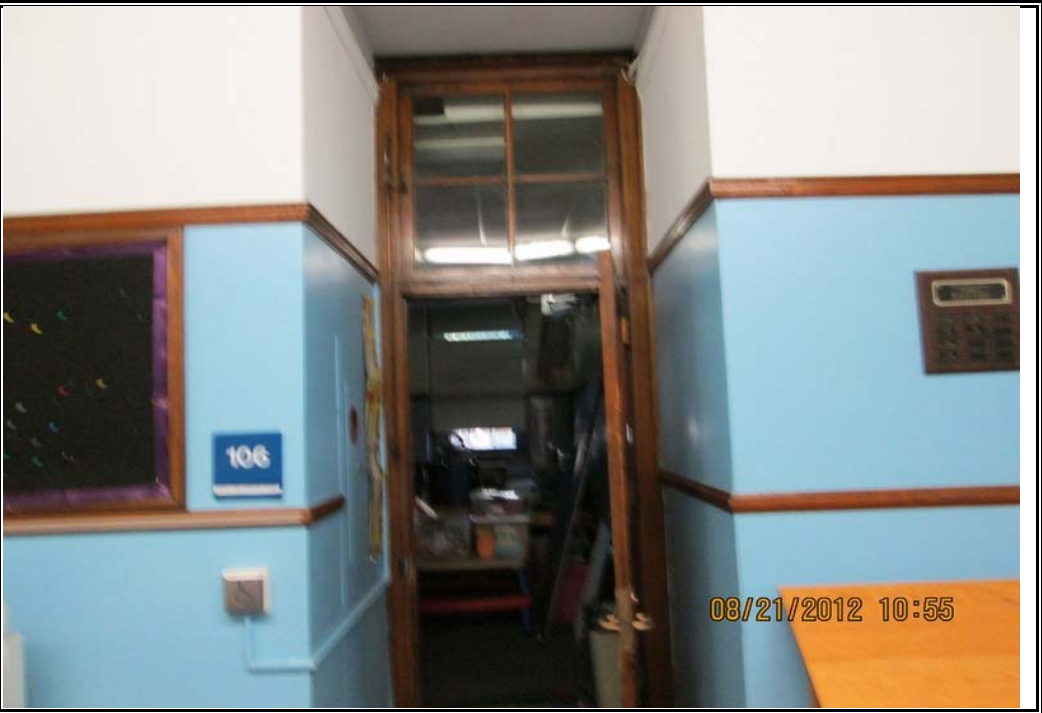
Photo #24

Description:  
Recessed entrance  
leading to Room 106 -  
Library (typical of all  
classrooms)

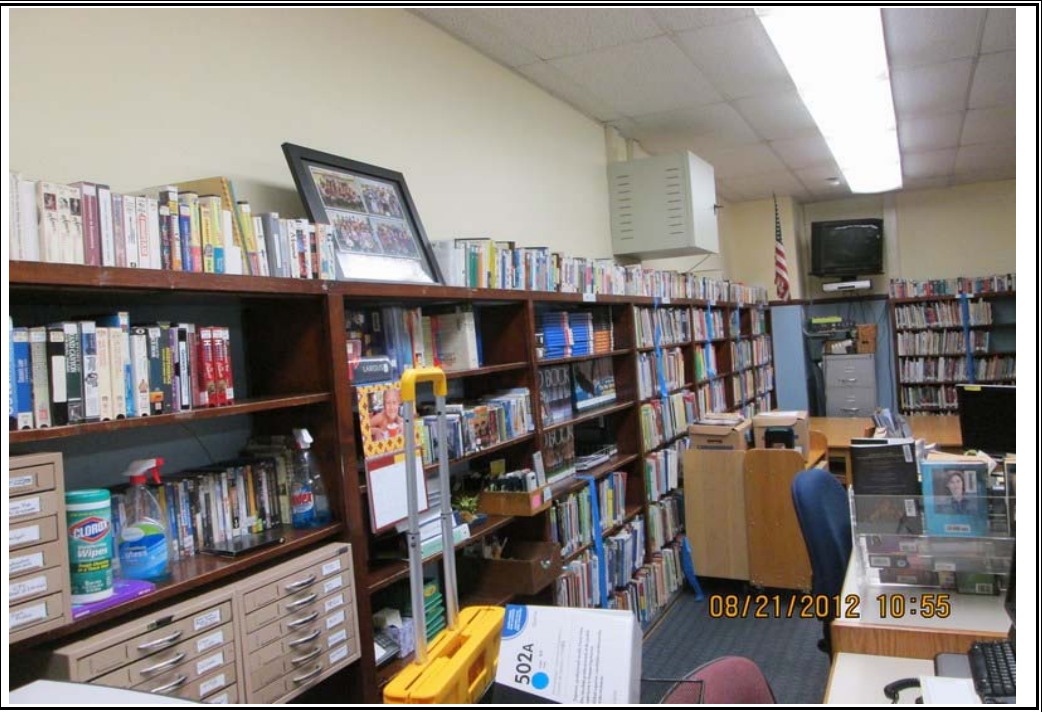
Photo #25

Description:  
Interior of Room 106 -  
Library

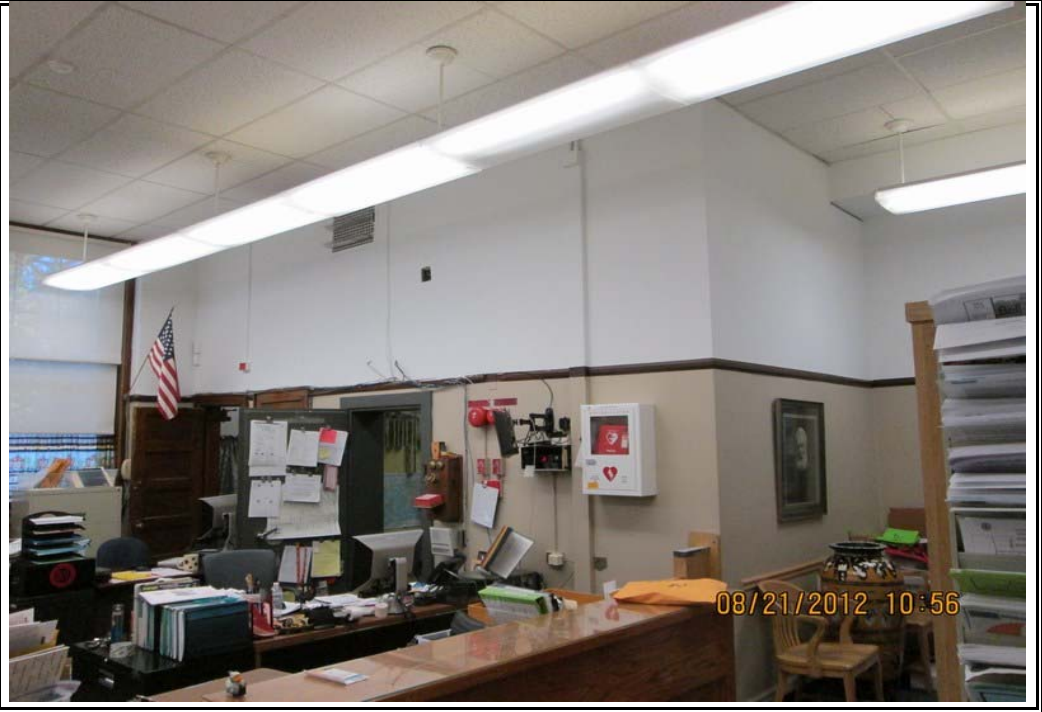
Photo #27

Description:  
Interior of Room 100 -  
Office

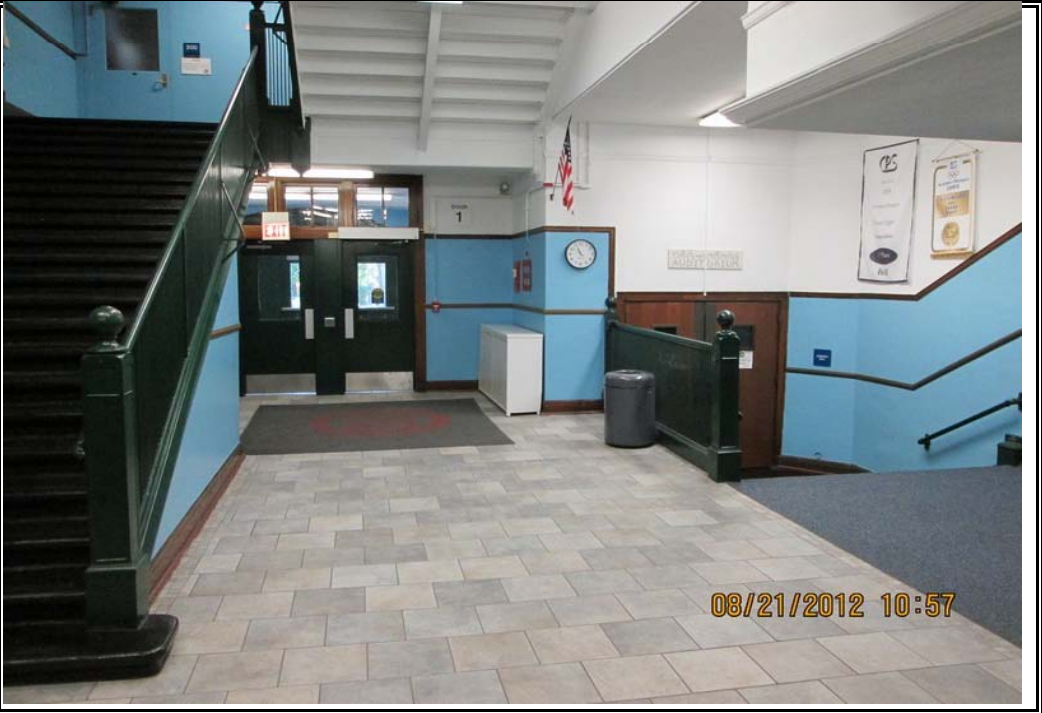
Photo #28

Description:  
Vestibule B/Hallway  
north of Auditorium

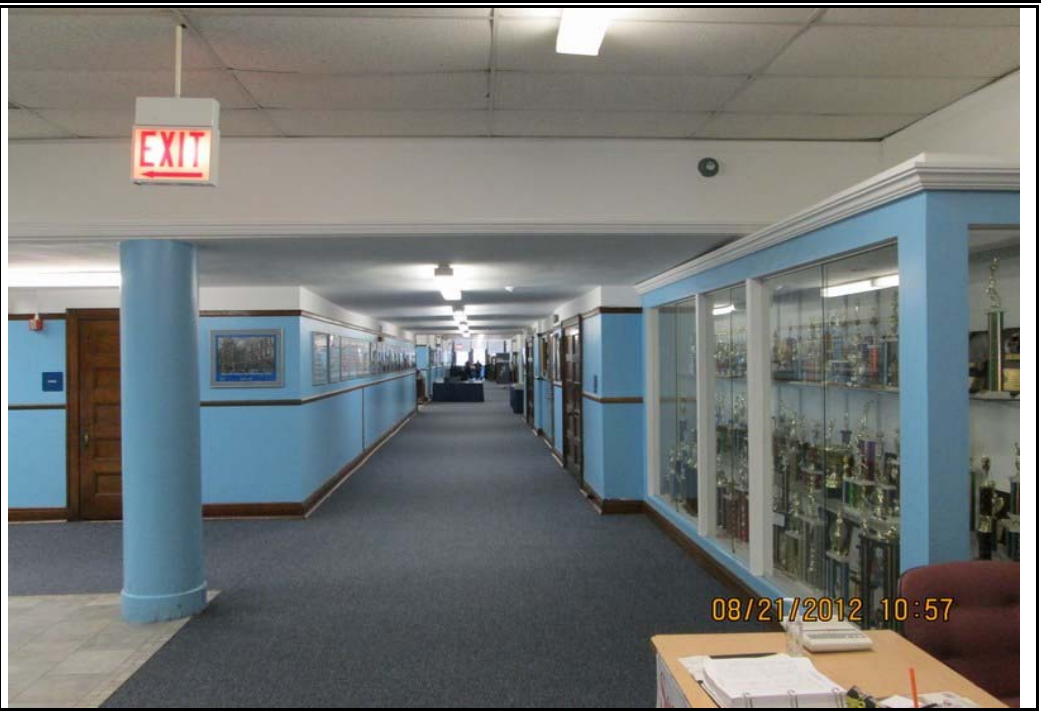
Project #: 1261.028 Date: 10/21/2012 Photographed By: Randy Livingston
Description: Main hallway - first floor
Photo #29

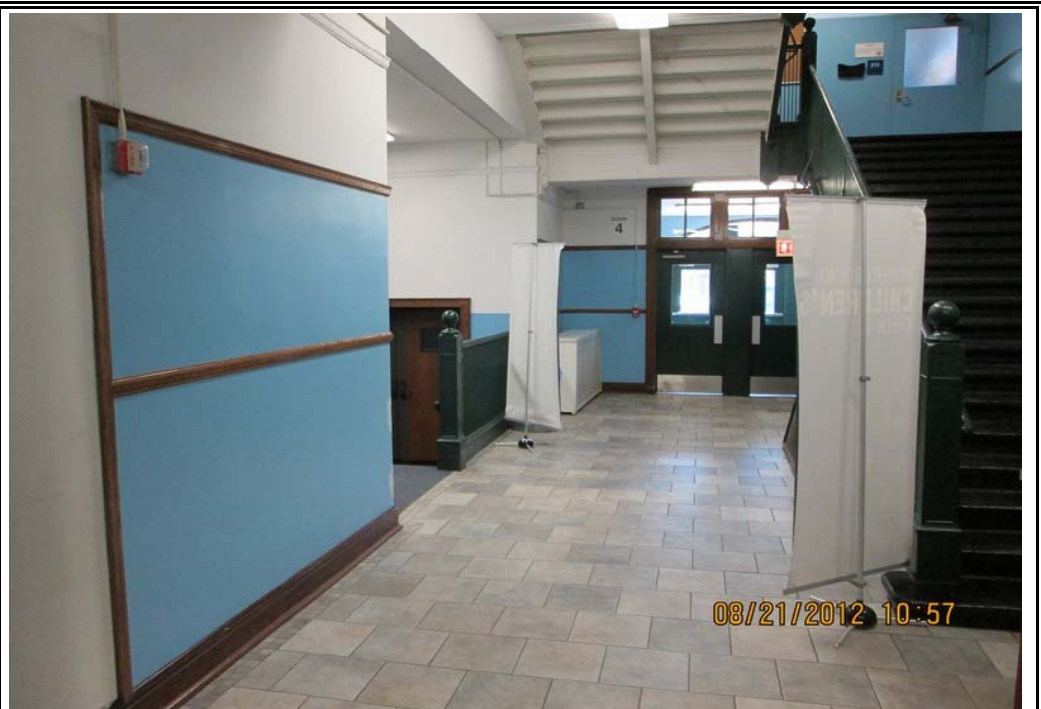
Project #: 1261.028 Date: 10/21/2012 Photographed By: Randy Livingston
Description: Vestibule A/Hallway south of Auditorium
Photo #30

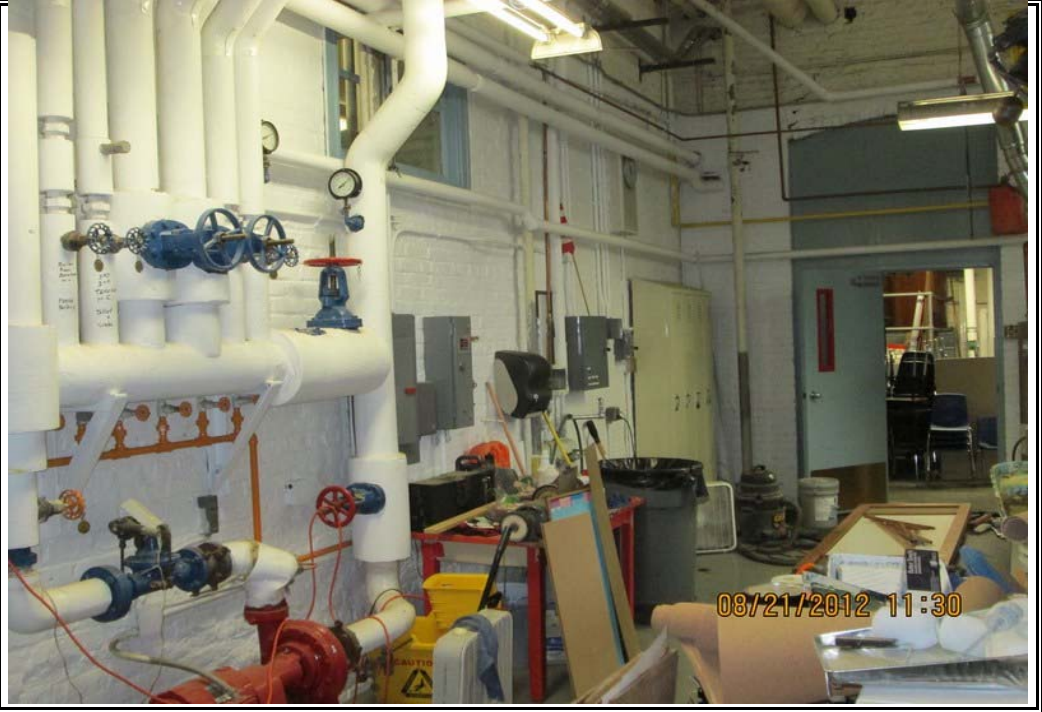
Photo #31

Description:  
Pipe valves in Boiler  
Room

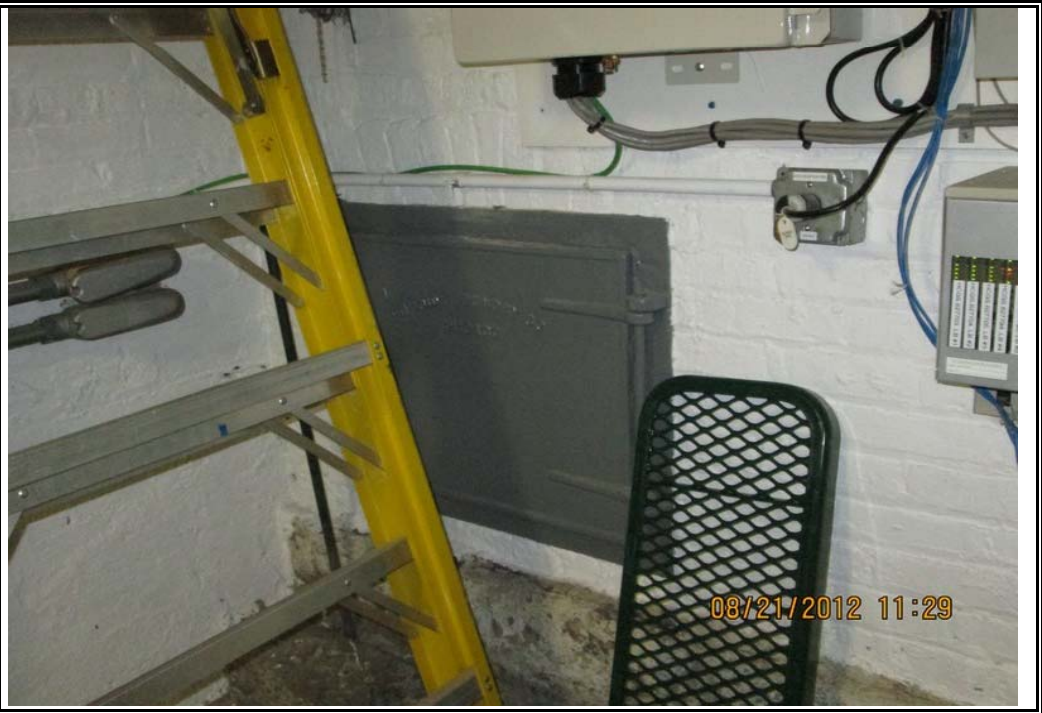
Photo #32

Description:  
Door to Incinerator in  
lower portion of Boiler  
Room

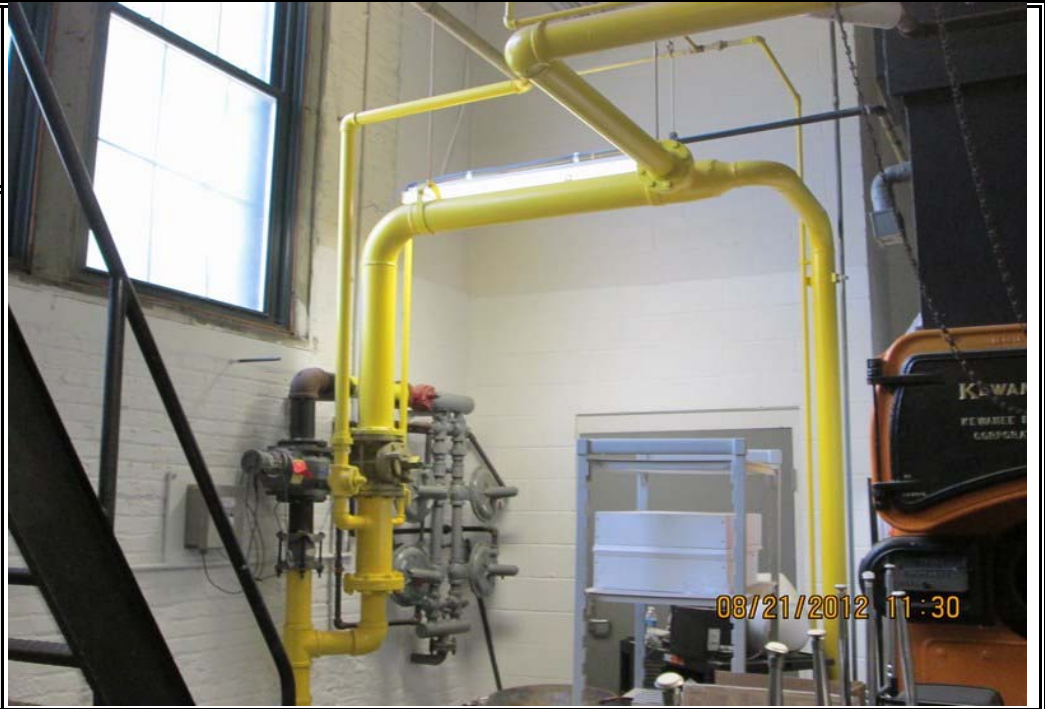
Photo #33

Description: Window casing in Boiler Room
---

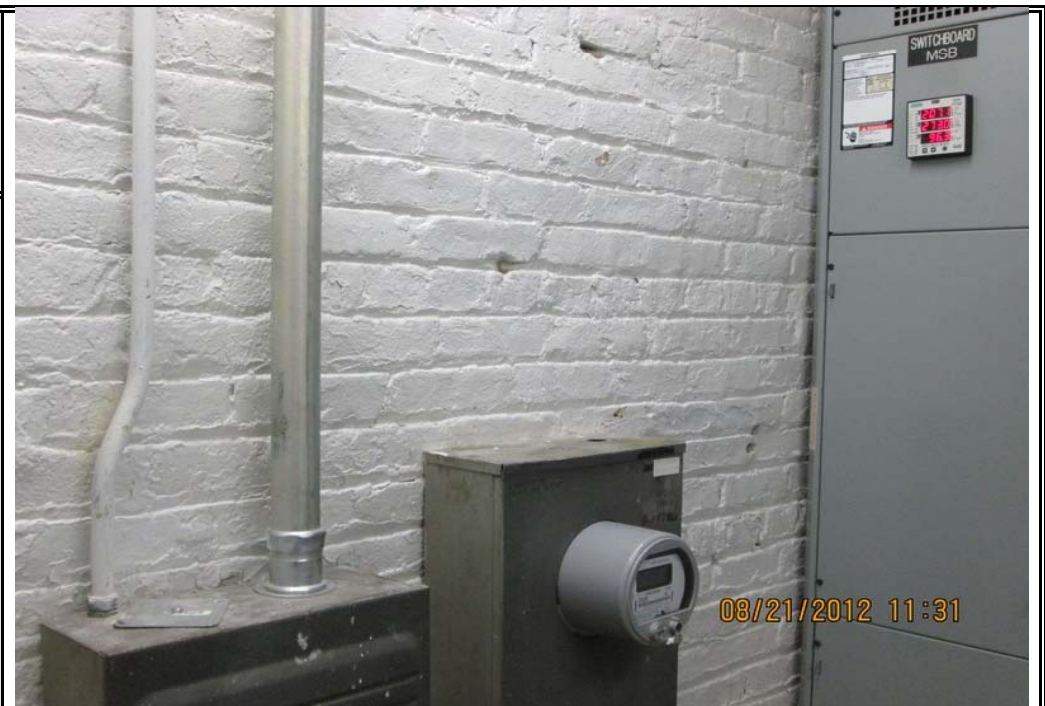
Photo #34

Description: Door to Electrical Room inside Boiler Room (lower portion)
--

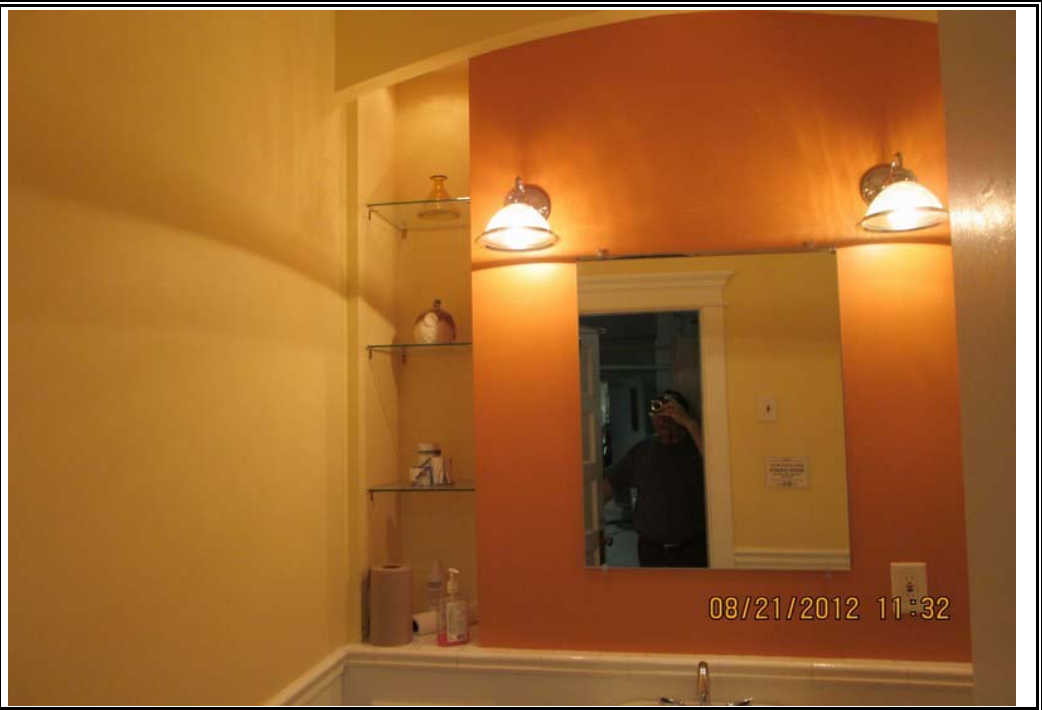
Photo #35

Description:  
Bathroom inside Boiler  
Room

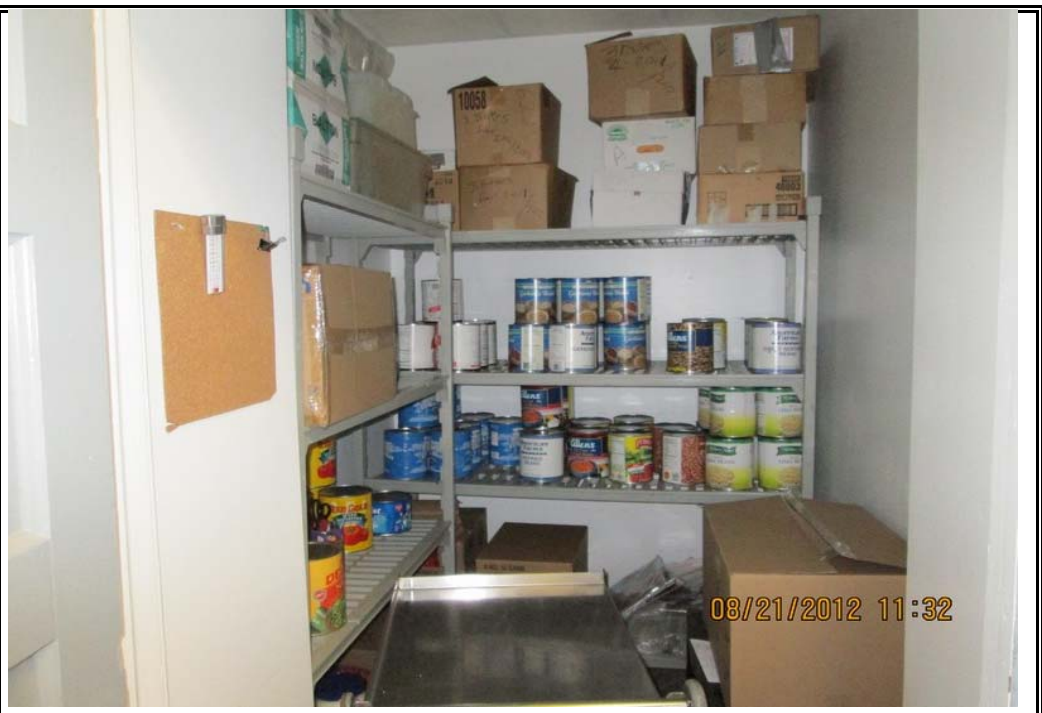
Photo #36

Description:  
Pantry inside Boiler  
Room

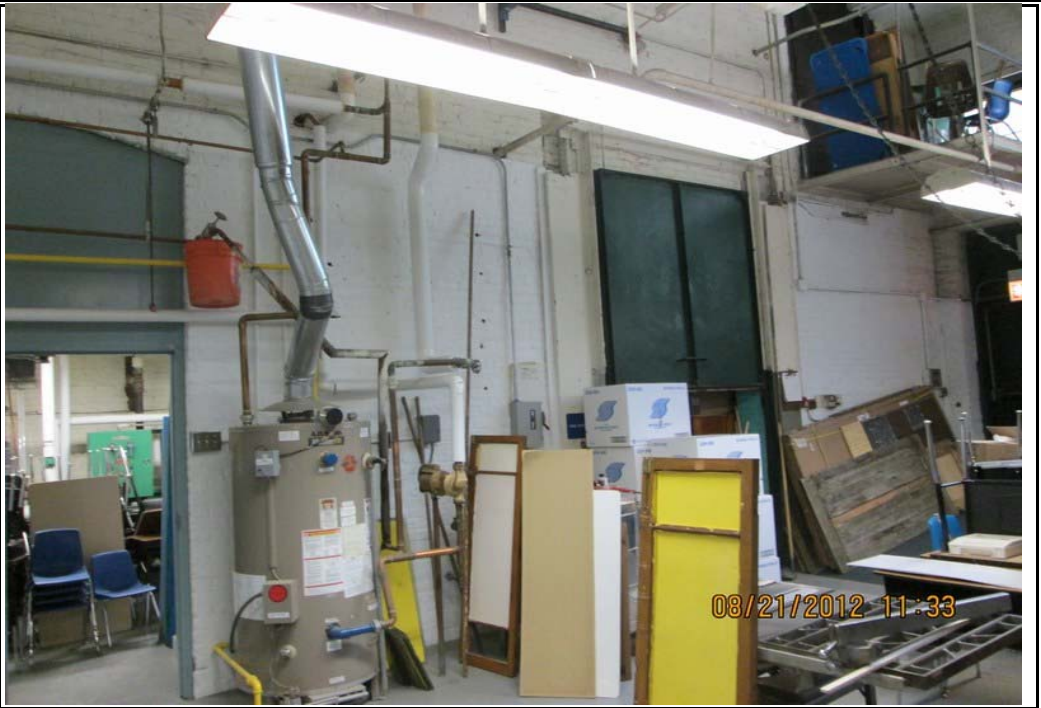
Photo #37

Description:  
Interior of Boiler Room

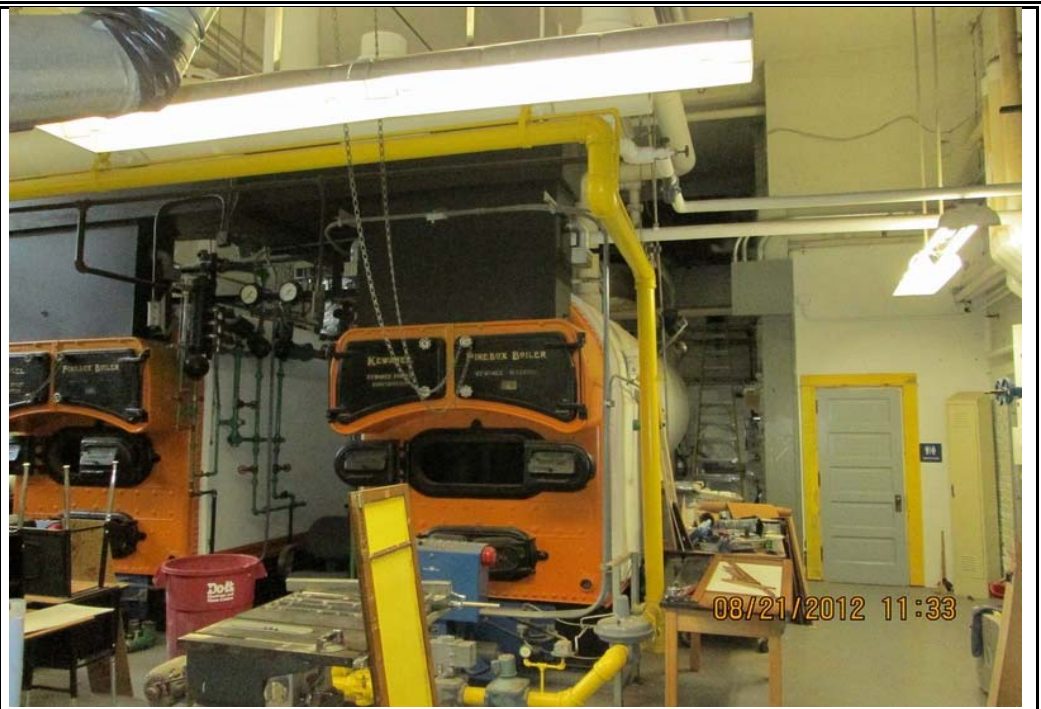
Photo #38

Description:  
Door to Boiler Room  
bathroom
